Report of the Royal Commission

appointed to inquire into

Australian Standard Garratt Locomotive

1946

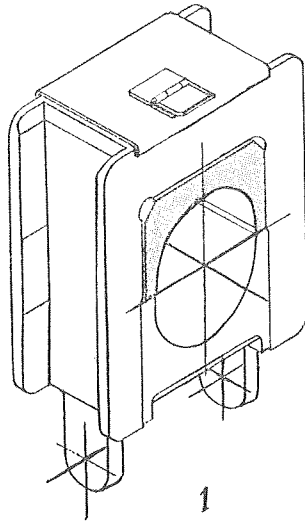
SKETCH No. 1.—Prior to alterations.

The original design of the box and the bearing surface of the brass which is intended to take the hub of the wheel as it oscillates when revolving did not allow sufficient bearing surface to reduce frictional wear set up by the hub face. In consequence, very rapid and excessive wear of the brasses took place. In order to rectify this trouble steps were taken to increase the bearing surface for the wheel hub by welding a metal plate to the box. White metal inserts were also provided at the bearing where it rests on the journal, and where the bearing surface which came into contact with the hub was worn it was built up with white metal. A marked improvement resulted. These steps were taken in Queensland and in Tasmania. Mr. Mills, the designer, stated that in Western Australia, in view of the fact that coupled axle boxes might be expected to give 40,000 miles of service before removal and that hub liners had not been found necessary, nothing would be done until the locomotives were in shops for general overhaul, when hub liners would be fitted for the purpose of extending the period of service already anticipated. Hereunder are two perspective sketches showing an exterior aspect of an axle box bearing in the horns provided at the frame. The first sketch shows the bearing in the box before provision was made for the alterations, and the other sketch shows the effect of the alterations which were made. It will be noted how small was the bearing surface originally provided and the substantial increase which was made by the alterations.

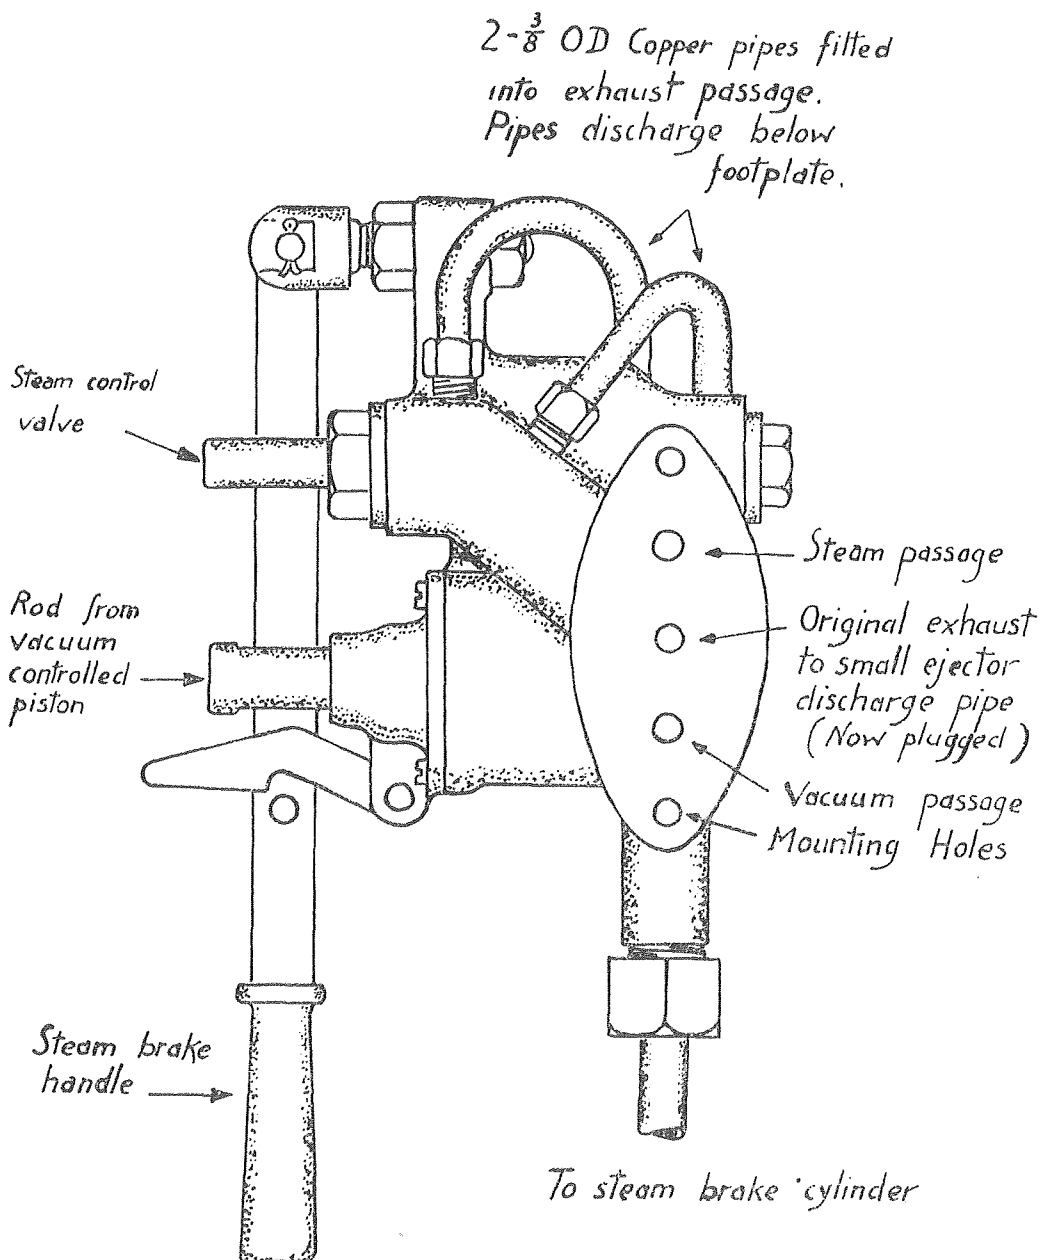
The last two ASG locomotives delivered to the Tasmanian Government Railways are fitted with an automatic steam brake mounting similar to those previously fitted but the steam brake exhaust is discharged direct to atmosphere through a 1 in. O.D. copper pipe. Results with this mounting are said to be satisfactory, release of the steam brake being complete by the time a normal operating vacuum has been restored to the train pipe. The restoration of the vacuum is not interfered with by the steam brake exhaust. The proprietary fitting has now been designed with an improved mounting for the ASG locomotives, intended to overcome the difficulty just discussed.

The sketch hereunder shows the steam brake mounting. The hole through which the exhaust steam was discharged to the small ejector pipe is shown as well as the two copper pipes which were fitted by the Tasmanian Government Railways to the exhaust passages in the steam brake mounting.

Reference has been made to the expedient suggested by the railway officers of making several short applications of the brake before a full application. The purpose was to clear the brake cylinder of condensate which robbed the steam of its efficiency and impeded the application of the brake. The design is definitely faulty in not providing for a release cock to discharge the water when the brake mechanism is applied. In no instance where I have inquired have brake cylinders of steam brakes been designed without this provision. The design has been used for many years in accordance with this practice. In Tasmania, not only has provision been made for ready drainage from the cylinder by means of a drain cock, but similar provision has been made to take away condensation in the steam brake pipe.

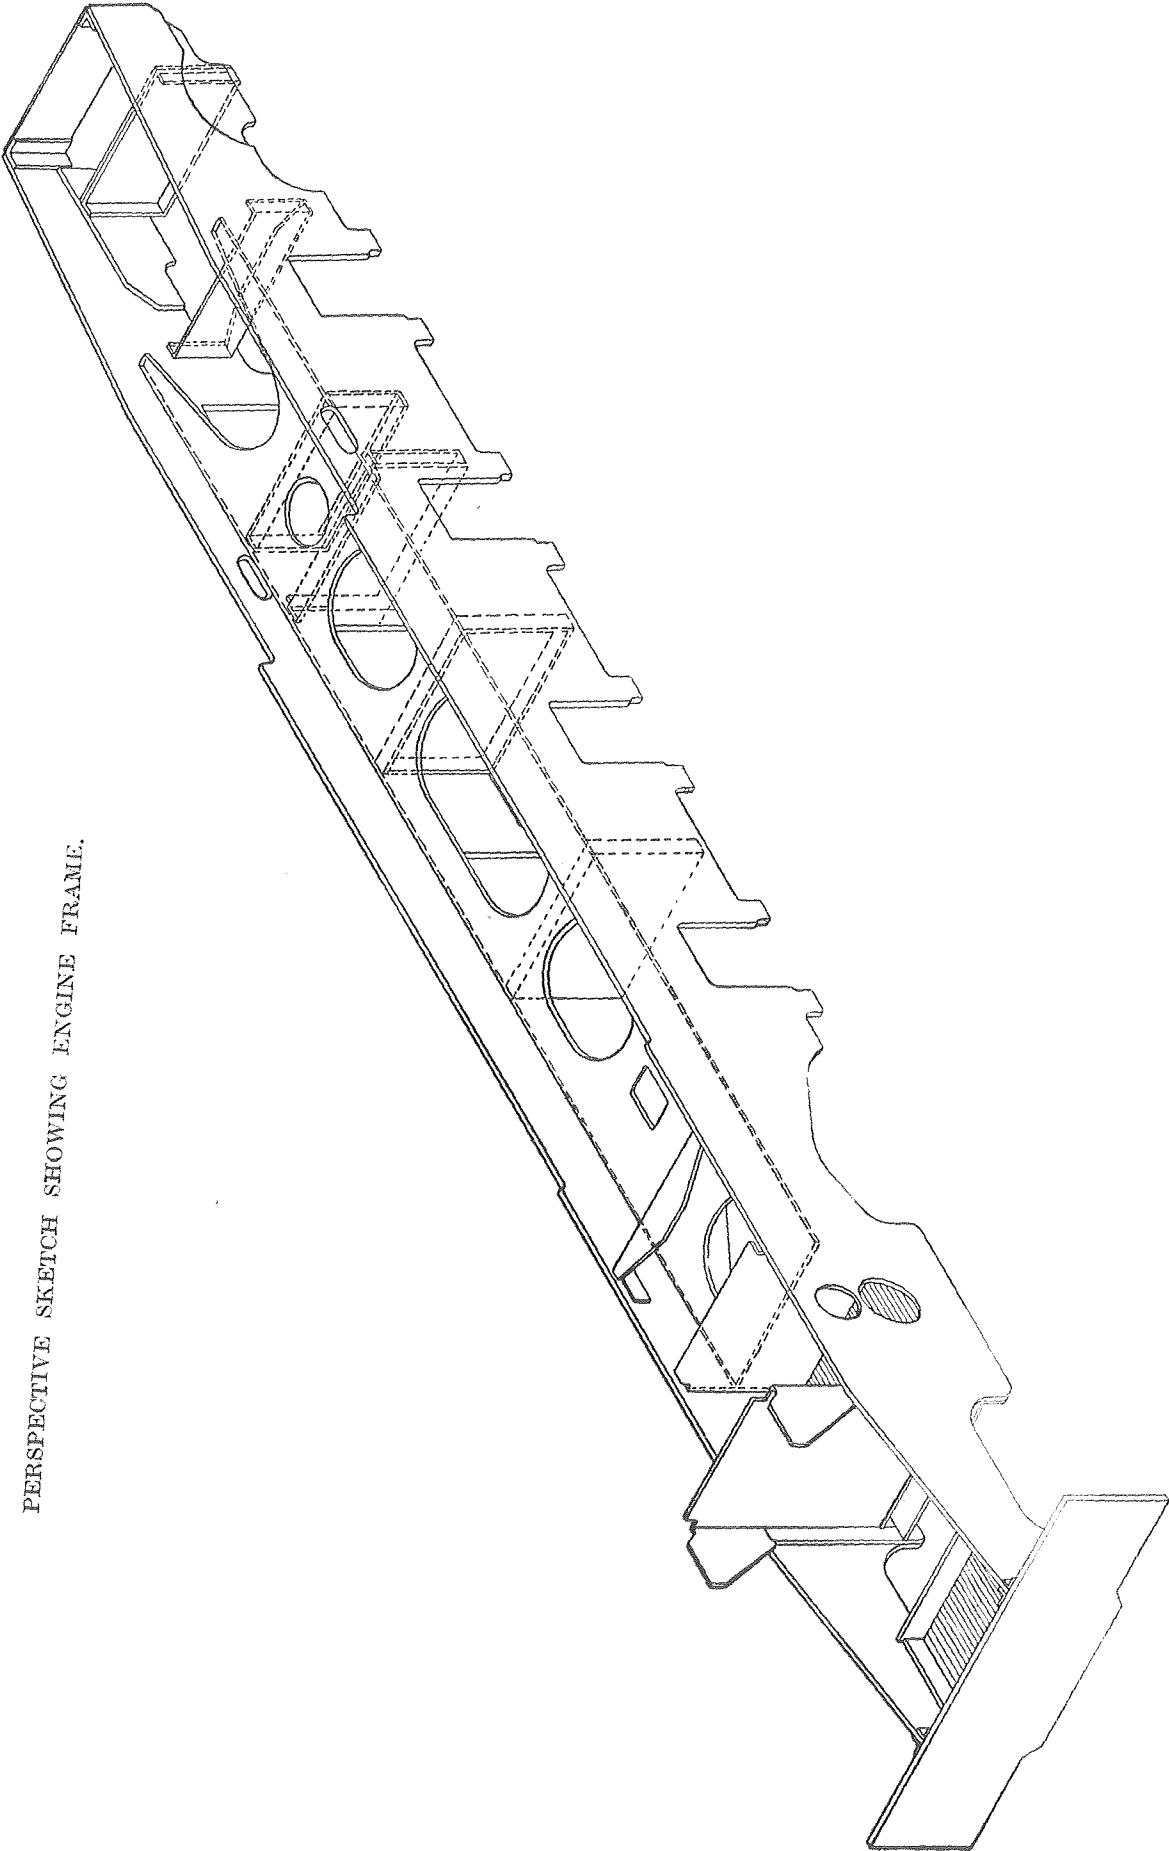
PERSPECTIVE SKETCH SHOWING ENGINE FRAME.

As in the case of the engine frames, where additional weights were added to the upper structure, additional weights were also added to the upper structure on the boiler cradle frame by increasing the size of the firebox and boiler.

Quite early, the cross members of the boiler cradle frame showed excessive deflection in service and it became necessary to strengthen these by inserting gussets and additional cross members to stiffen up the plate where the male section of the pivot is installed. These measures seem to have effected the required strengthening and no further deflection has been reported.

The first locomotives were issued from the shops with the pivot centres in cast iron and under the stress of the deflection at the plate where the male section was installed these pivot centres cracked. They were replaced by steel castings, and since the frame was stiffened there is no record of any further breakages.

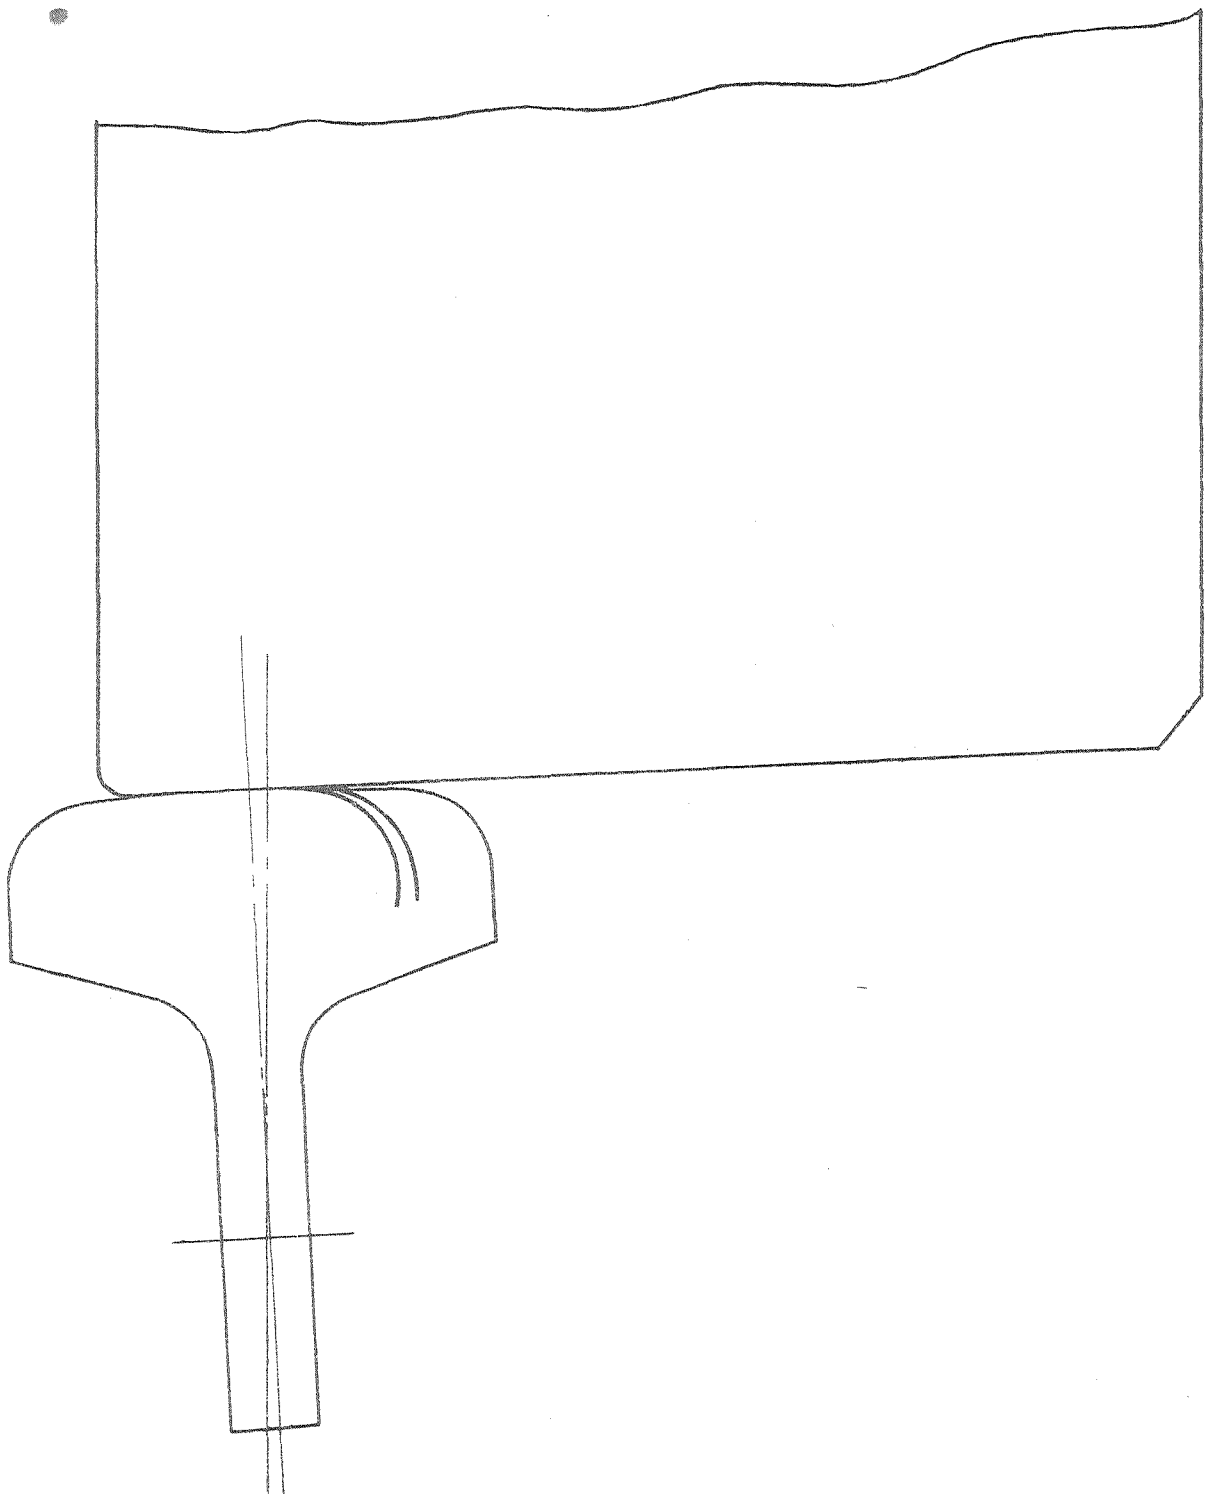
APPENDIX VII.

The width of the leading flangeless wheel is $5\frac{3}{4}$ inches, so it is obvious that if the facts given me are correct there must have been a fair amount of give either in the engine or the rails, or both, for these wheels to have got in the position they did. Nothing was done to the track where the engine derailed as it was found to be in order, but the road under the truck was distorted. Mr. Mills, the designer, advances the opinion that the spring of the rail could permit the dropping over of the flangeless wheels. I do not think that the possible deflection in the frame of the engine could account in any material measure for this happening. The condition of the boxes could have been a vital factor in the cause of this peculiar incident, but there is no evidence on this point. The position is that in the vague and sketchy outline of what took place I find it impossible to arrive at any definite conclusion, or to find that there is, in all the circumstances, any evidence which points definitely to a defect in the locomotive design.

Sketch showing flangeless wheel bearing on 45lb. rail and 60lb. rail, and demonstrating the small amount of bearing surface.

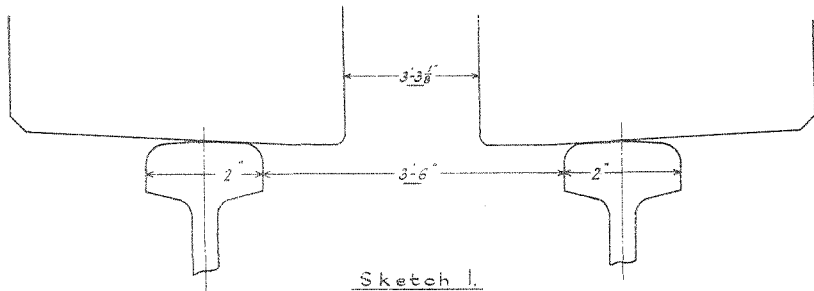
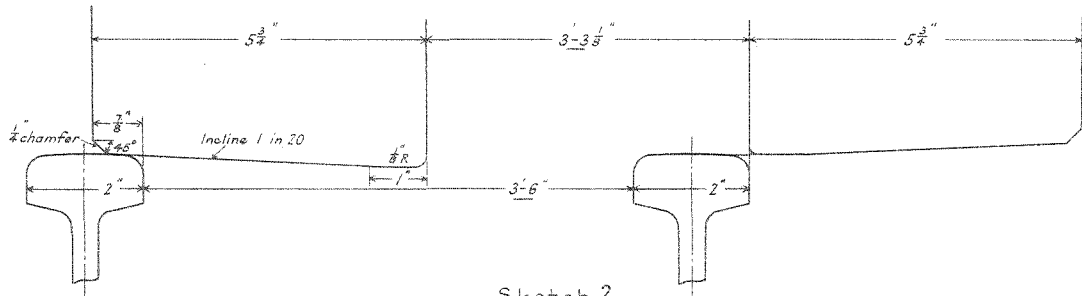
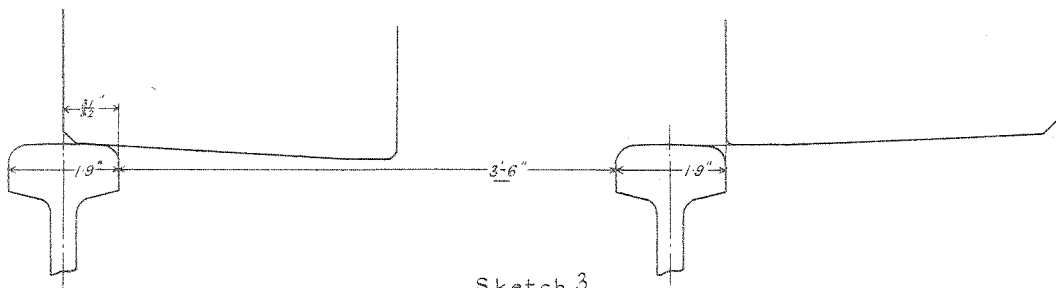
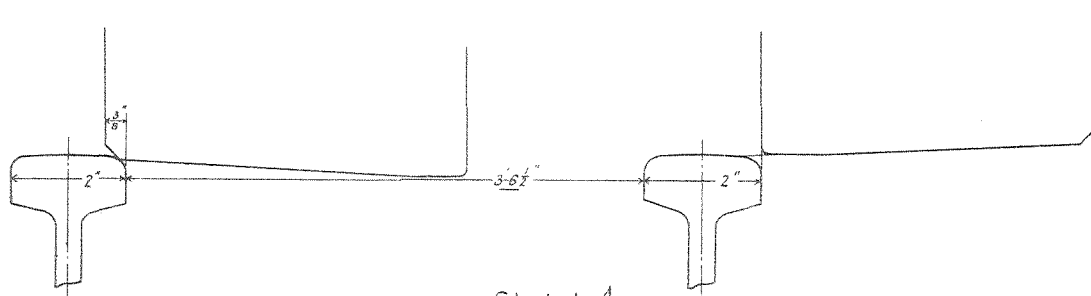
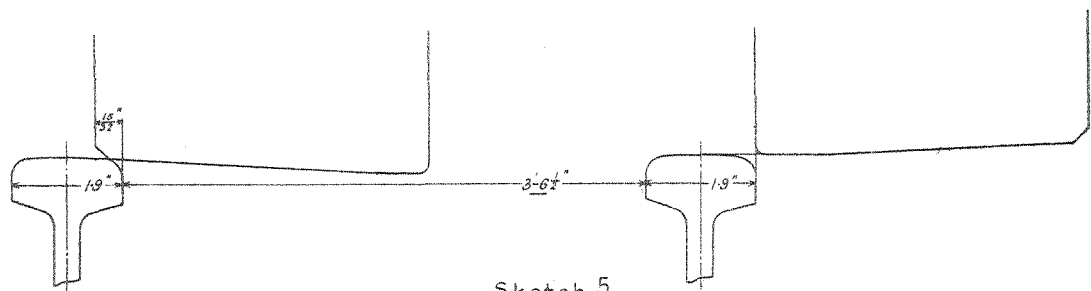
APPENDIX VIII.

5. The wheel of the locomotive which drops off on the high leg will be found brightly ringed around the exterior margin of the face which rubs against the side of the rail. Where the other wheel drops off it is similarly marked with a bright ring on the exterior margin of the face which rubs against the side of the rail. It does not follow that because one wheel drops off the rail the other wheel will derail. This can be illustrated diagrammatically.

Sketch No. 3 illustrates a similar set of conditions but with a railhead of 1.9 inches. Here the seating is $\frac{31}{32}$ nds of an inch when the other wheel is line and line with the outside edge of the other rail. Sketch No. 4 is intended as an illustration of the bearing surface which one wheel has on the low leg of a five-chain curve which is widened in accordance with standard practice in Western Australia. This shows that when the wheel on the low leg has a bearing of $\frac{3}{8}$ ths of an inch the other wheel is line and line with the outer edge of the other rail. In this case the railhead is two inches in section. Sketch No. 5 shows that under similar conditions, but with a railhead of 1.9 inches, when the wheel on the low leg has a bearing of $\frac{15}{32}$ nds of an inch the other wheel is line and line with the outer edge of the other rail.

Diagrams illustrating how one leading flangeless wheel may drop off the rail while the other is still riding on the bearing surface of the other rail.
